## **Eliminating Compressed Air/Gas Leaks Using an Ultrasound Tool**

**VILLALBA CRDM CLEAN ROOM**

**COMPRESSED AIR / GAS AUDIT**

**ULTRASOUND ROUTE DEC-09**

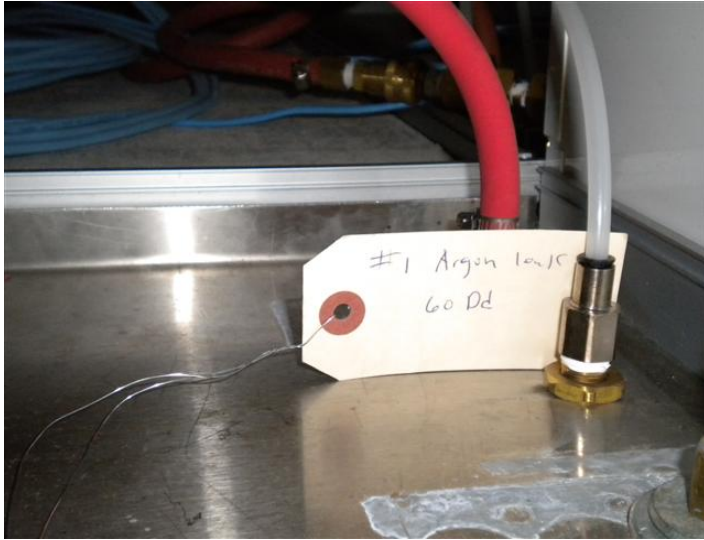
**DSCN0178.jpg**  
12/5/2009 7:08:24 AM

**ARGON LEAK**

Location: Clean Room D

Equipment: Argon line Ceiling plate D11

Decibel Level: 60db

Air Pressure: 90psi

Problem Description: Leaking above ceiling around the threads.

Recommended Repairs: Repaired and re-checked

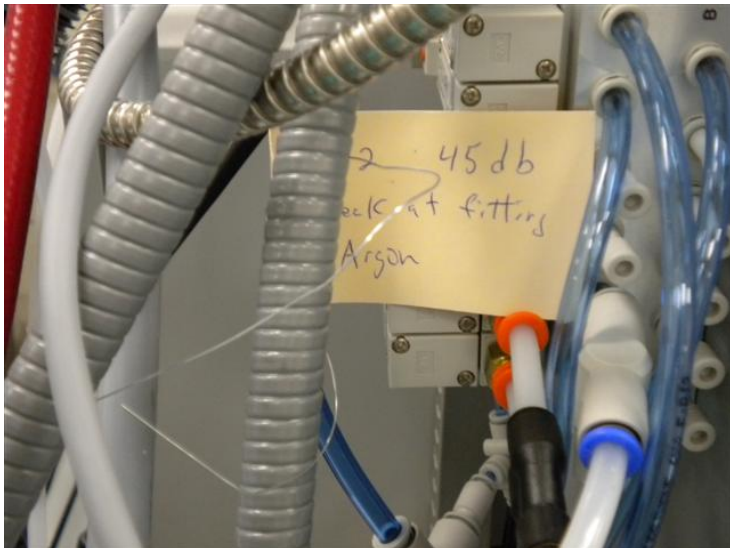
**DSCN0179.jpg**  
12/5/2009 7:13:56 AM

**ARGON LEAK**

Location: Clean Room D

Equipment: Lasag Machine

Decibel Level: 45db

Air Pressure: 42psi

Problem Description: Leaking at the fitting

Recommended Repairs: Repaired and re-checked

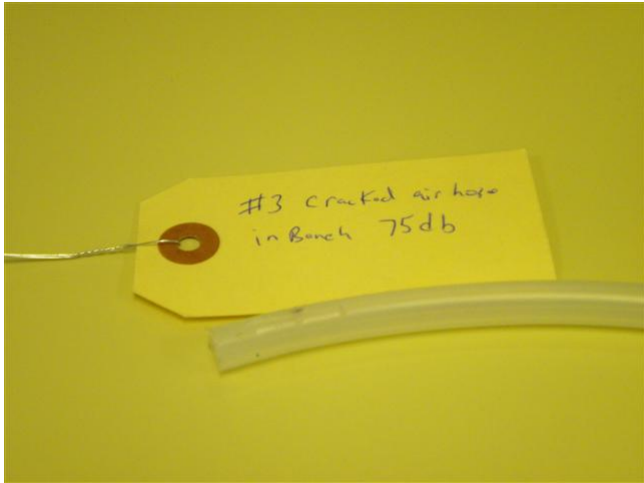
12/5/2009 7:43:08 AM

Location: Clean Room D

**AIR LEAK IN WORK BENCH**

Equipment: Work bench

Decibel Level: 75db

Air Pressure: 110psi

Problem Description: Cracked 3/8" hose inside work bench

Recommended Repairs: Repaired and re-checked

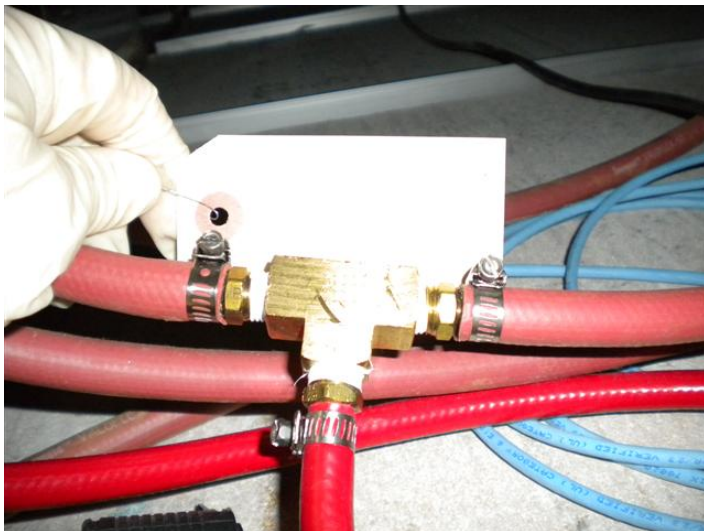
DSCN0184.jpg  
12/5/2009 8:20:06 AM

**ABOVE CEILING FITTING LEAKING**

Location: Clean Room E

Equipment: Fitting above ceiling by ceiling plate E-45

Decibel Level: 45db

Air Pressure: 110psi

Problem Description: Leaking around threads

Recommended Repairs: Repaired and re-checked

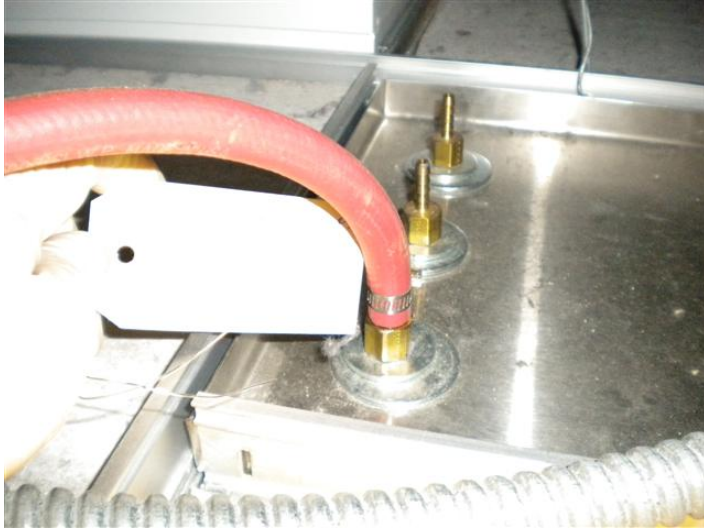
**DSCN0186.jpg**

**ABOVE CEILING INTO CEILING PLATE**

Location: Clean Room E

Equipment: Ceiling plate E-39

Decibel Level: 50db

Air Pressure: 110psi

Problem Description: leaking at the fitting

Recommended Repairs: Repaired and re-checked

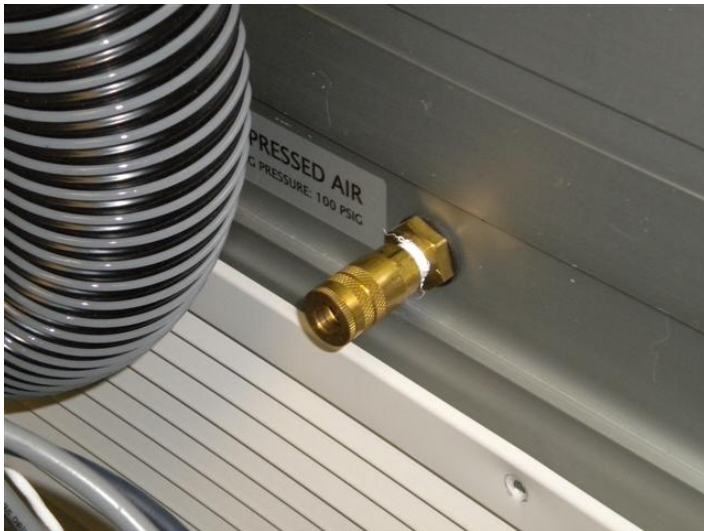
**DSCN0188.jpg**

**QUICK CONNECT FITTING**

Location: Clean Room E

Equipment: Fitting on back of machine by ceiling plate E-17

Decibel Level: 40db

Air Pressure: 110psi

Problem Description: Leaking around the threads

Recommended Repairs: Repaired and re-checked

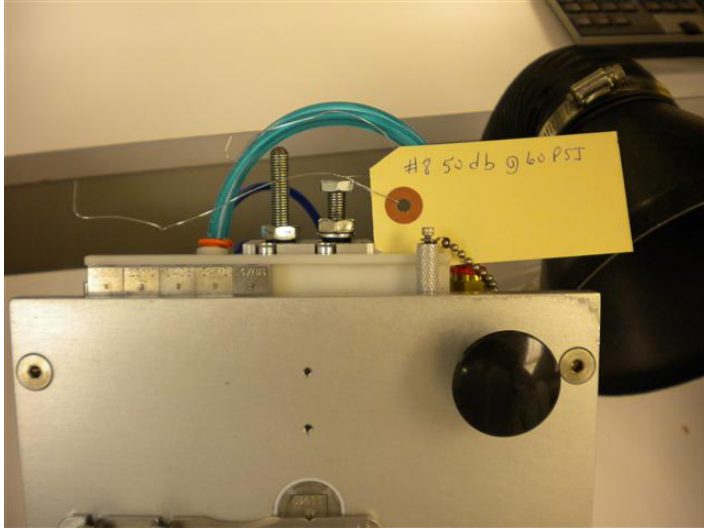
**DSCN0189.jpg**  
12/5/2009 9:18:26 AM

**LEAK ON BLOCK**

Location: Clean Room C

Equipment: Machine in Steer Area

Decibel Level: 50db

Air Pressure: 60psi

Problem Description: leaking around the terminal block, tightened

Recommended Repairs: Repaired and re-checked

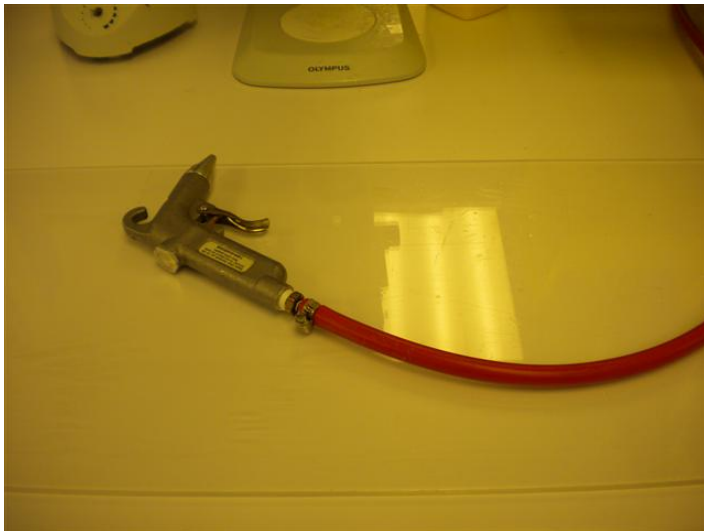
**DSCN0193.jpg**  
12/5/2009 9:46:16 AM

### LEAKING AIR HOSE

Location: Clean Room C

Equipment: Air hose Tubing leaking

Decibel Level: 50db

Air Pressure: 100psi

Problem Description: Leak in the hose and it was replaced

Recommended Repairs: Repaired and re-checked

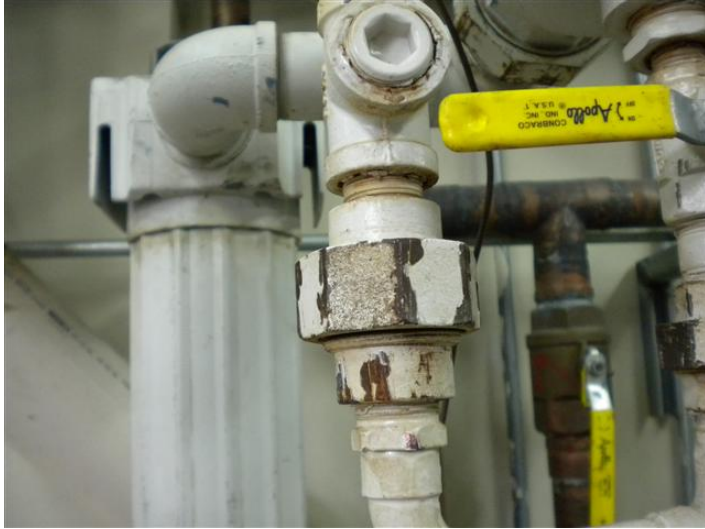
**DSCN0196.jpg**  
12/5/2009 10:20:02 AM

### UNION ON DRIER

Location: Air Compressor Room

Equipment: Hydro Bloc Drier

Decibel Level: 70db

Air Pressure: 110psi

Problem Description: Leaking out of the top of the union

Recommended Repairs: Repaired and re-checked

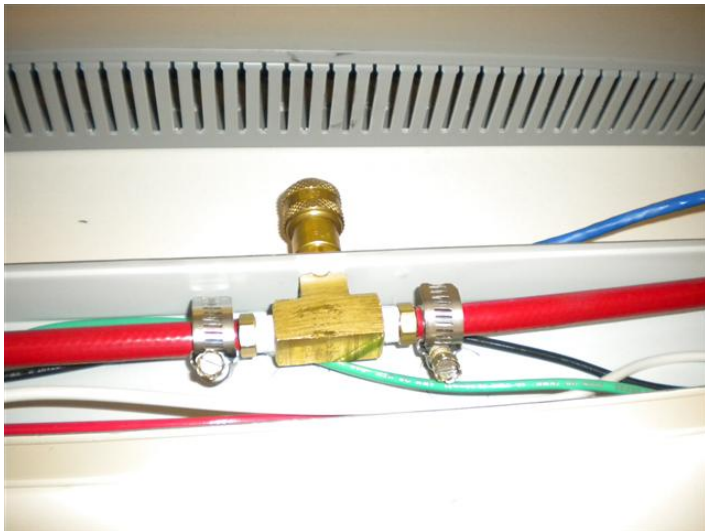
**DSCN0199.jpg**  
12/5/2009 10:52:56 AM

#### FITTING IN ELECTRIC CHASE

Location: Clean Room B

Equipment: Under bench at Quality Flow Improver

Decibel Level: 65db

Air Pressure: 110psi

Problem Description: Leaking on the fittings of the tee

Recommended Repairs: Repaired and re-checked

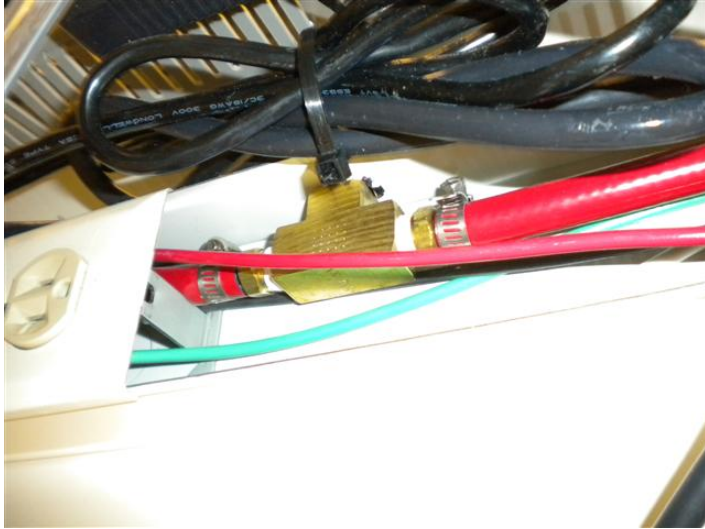
**DSCN0200.jpg**  
12/5/2009 11:00:34 AM

#### FITTING IN ELECTRICAL CHASE

Location: Clean Room B

Equipment: Below bench by Inner Coil Start Station

Decibel Level: 65db

Air Pressure: 110psi

Problem Description: Fitting leaking on the threads and hoses clamps

Recommended Repairs: Repaired and re-checked

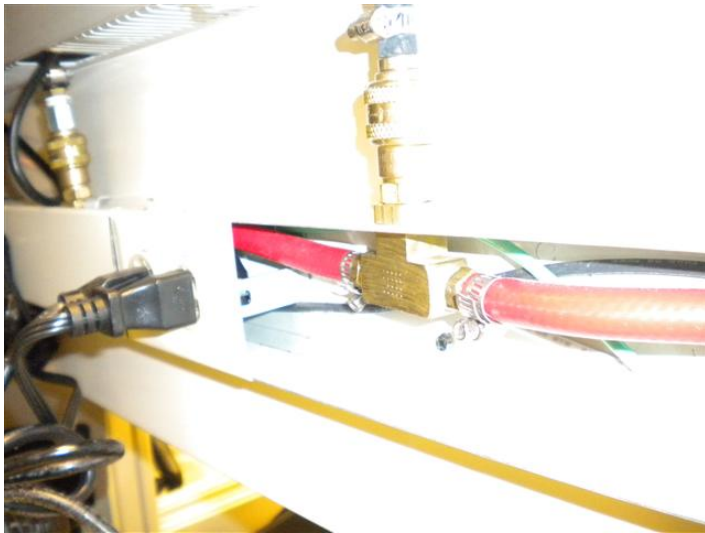
**DSCN0202.jpg**  
12/5/2009 11:15:32 AM

#### **FITTING IN ELECTRICAL CHASE**

Location: Clean Room B

Equipment: Tee fitting under bench by Inner Coil End

Decibel Level: 45db

Air Pressure: 110psi

Problem Description: leaking at the tee fitting

Recommended Repairs: Repaired and re-checked

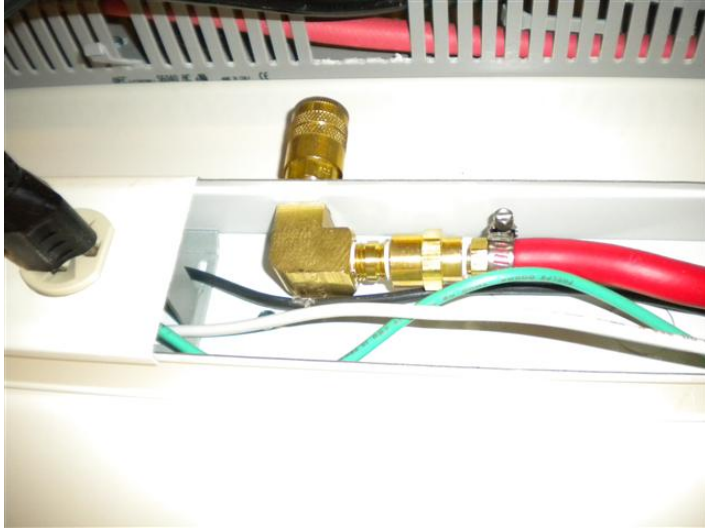
**DSCN0204.jpg**  
12/5/2009 11:20:16 AM

#### **FITTING IN ELECTRICAL CHASE**

Location: Clean Room B

Equipment: Below bench by Inner Tub End Station

Decibel Level: 60db

Air Pressure: 110psi

Problem Description: Leaking around threads and quick connect fitting

Recommended Repairs: Repaired and re-checked

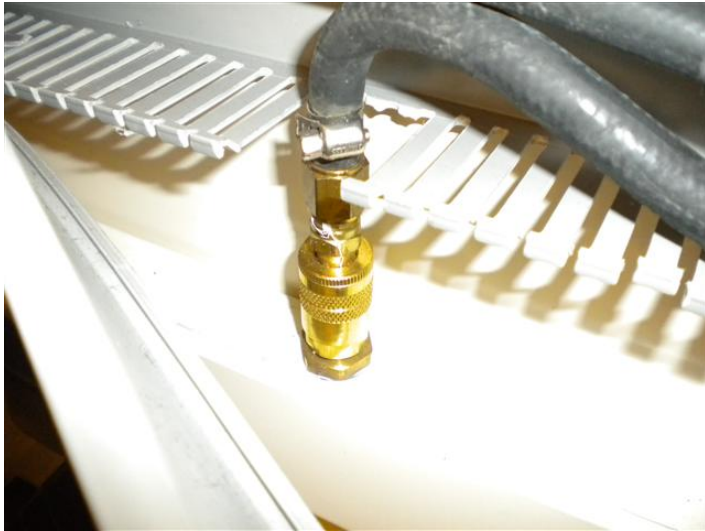
**DSCN0207.jpg**  
12/5/2009 11:29:20 AM

### HOSE CONNECTION FITTING

Location: Clean Room B

Equipment: Behind bench by Outer Coil Start Station

Decibel Level: 50db

Air Pressure: 110psi

Problem Description: Quick connect leaking

Recommended Repairs: Repaired and re-checked

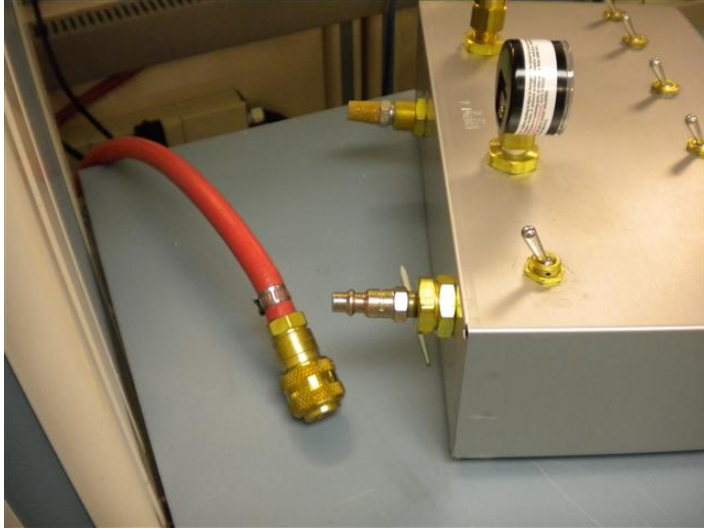
**DSCN0209.jpg**  
12/5/2009 11:35:58 AM

### FITTING TO MACHINE

Location: Clean Room B

Equipment: Machine equipment # MPR 08656

Decibel Level: 45db

Air Pressure: 110psi

Problem Description: Quick connect fitting leaking

Recommended Repairs: Repaired and re-checked

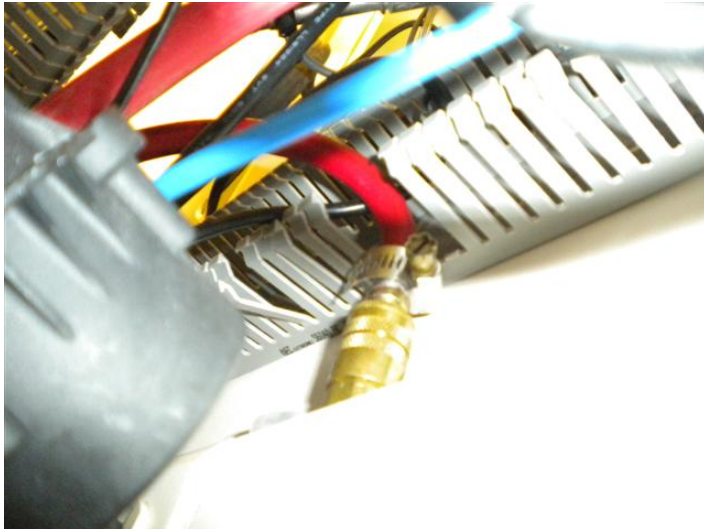
**DSCN0210.jpg**  
12/5/2009 11:42:52 AM

#### **FITTING BELOW BENCH**

Location: Clean Room B

Equipment: Below bench on Final Device Acceptance Station

Decibel Level: 45db

Air Pressure: 1110psi

Problem Description: Hose clamp leaking

Recommended Repairs: Repaired and re-checked

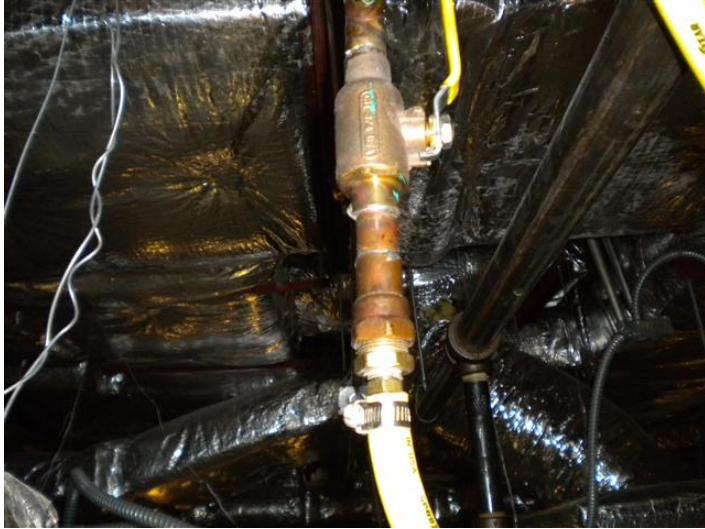
**DSCN0211.jpg**  
12/5/2009 11:50:20 AM

#### **LEAK ABOVE THE CEILING TILE**

Location: clean Room B

Equipment: Connection to main air above ceiling tile

Decibel Level: 45db

Air Pressure: 110psi

Problem Description: Clamp leaking

Recommended Repairs: Repaired and re-checked

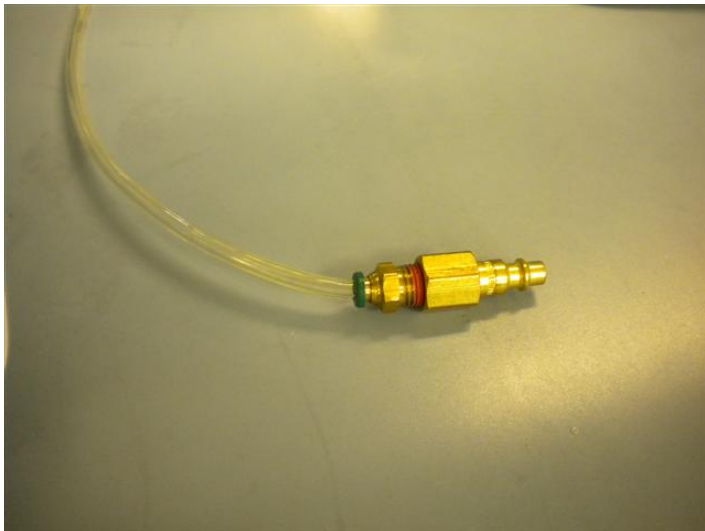
**DSCN0212.jpg**  
12/5/2009 12:00:54 PM

### QUICK CONNECT FITTING LEAKING

Location: Clean Room B

Equipment: Adhesive Dispenser  
MPR09764

Decibel Level: 40db

Air Pressure: 110psi

Problem Description: Tubing leaking at the quick connect

Recommended Repairs: Repaired and re-checked

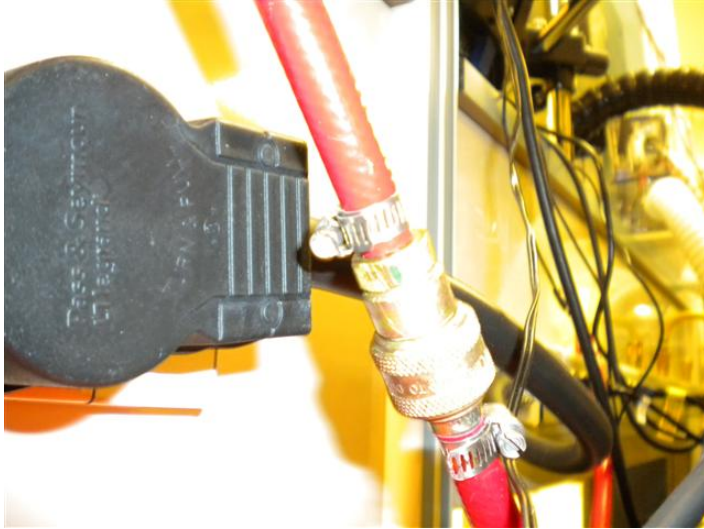
**DSCN0213.jpg**  
12/5/2009 12:05:42 PM

### QUICK CONNECT FITTING

Location: Clean Room B

Equipment: Near Unipolar Cell Station

Decibel Level: 45db

Air Pressure: 110psi

Problem Description: Hose clamp fitting needed to be tightened

Recommended Repairs: Repaired and re-checked

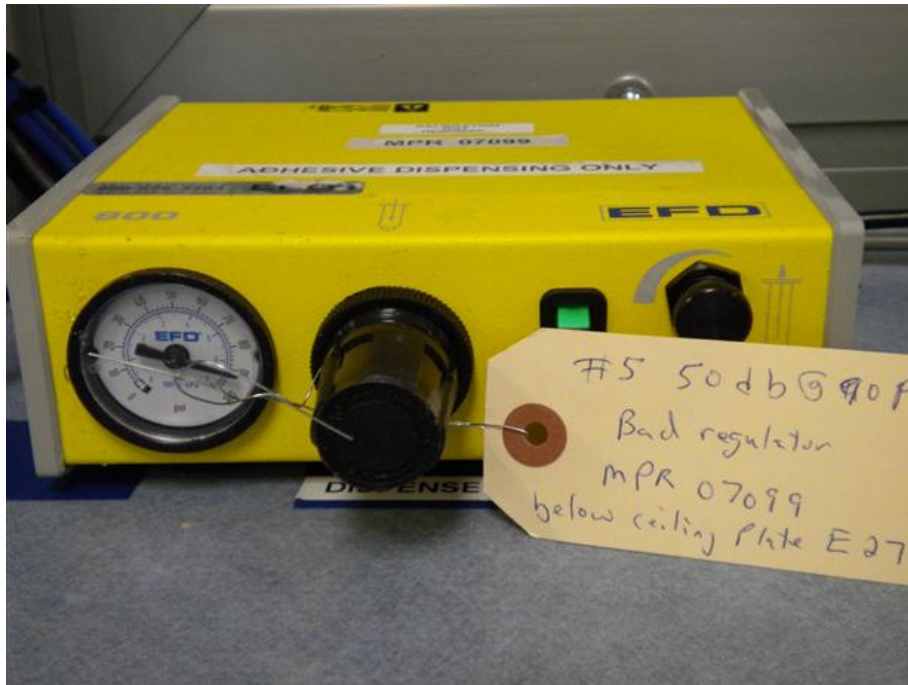
**DSCN0187.jpg**  
12/5/2009 8:31:48 AM

**REGULATOR LEAKING**

**Location:** Clean Room E by ceiling plate E-27

**Equipment:** Adhesive Dispenser MPR 07099

**Decibel Level:** 50db

**Air Pressure:** 90psi

**Problem Description:** Leaking from the regulator

**Recommended Repairs:** Repair or replace as needed.

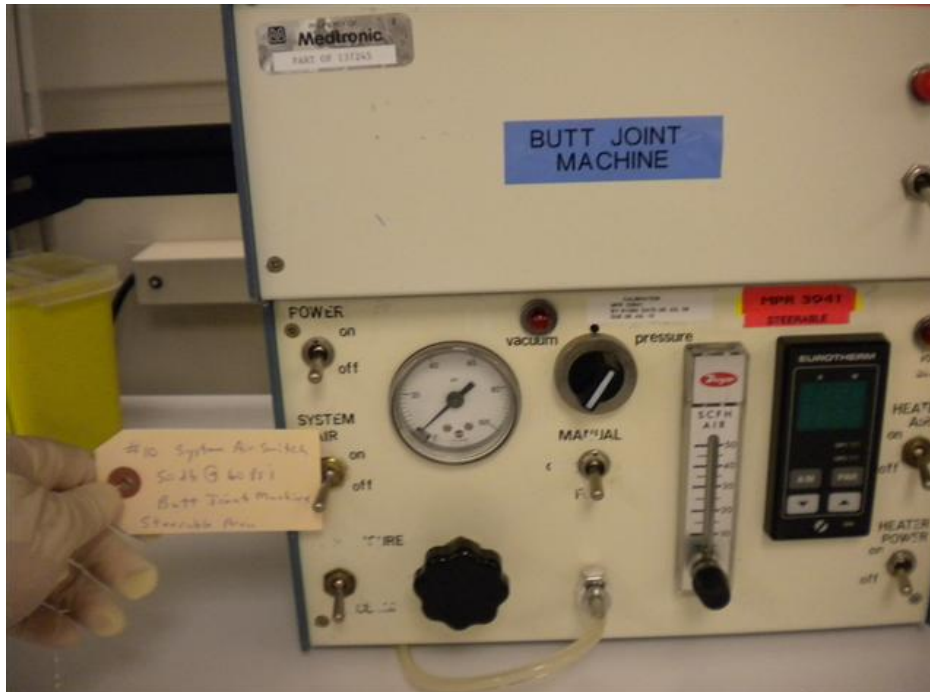
DSCN0192.jpg  
12/5/2009 9:43:18 AM

**SYSTEM AIR SWITCH**

**Location: Clean Room C Sterilizable Area**

**Equipment: Butt Joint Machine**

**Decibel Level: 50db**

**Air Pressure: 60psi**

**Problem Description: Leaking around the system air switch**

**Recommended Repairs: Repair or replace as needed**

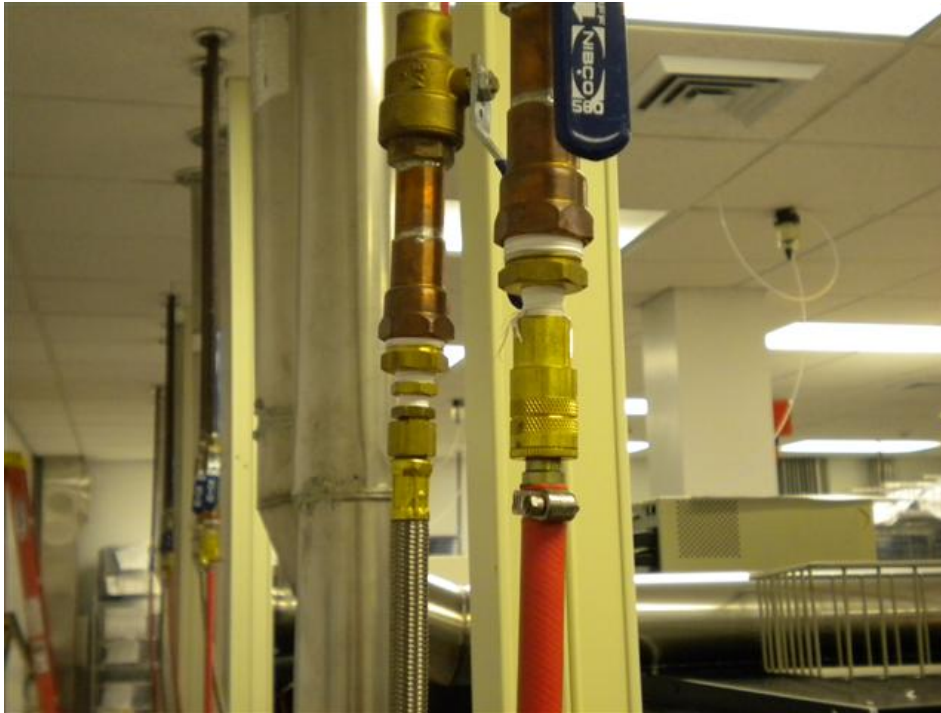
**DSCN0194.jpg**  
12/5/2009 10:11:00 AM

**FITTING LEAKING**

**Location: Sterilizer room**

**Equipment: Sterilizer 5XLE-53**

**Decibel Level: 35db**

**Air Pressure: 110psi**

**Problem Description: Leaking from around the threads**

**Recommended Repairs: Tighten-up or replace as needed**

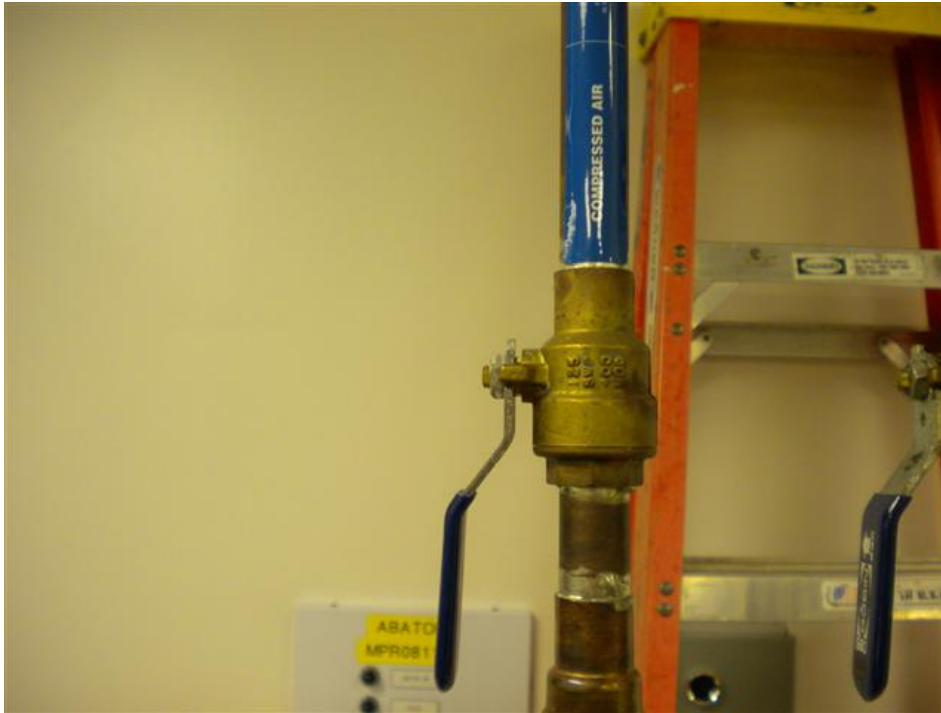
**DSCN0195.jpg**

**VALVE STEM LEAKING**

**Location: sterilizer Room**

**Equipment: sterilizer 5XLE-56**

**Decibel Level: 40db**

**Air Pressure: 110psi**

**Problem Description: Leaking from the valve stem**

**Recommended Repairs: Tighten-up the packing nut or replace valve**

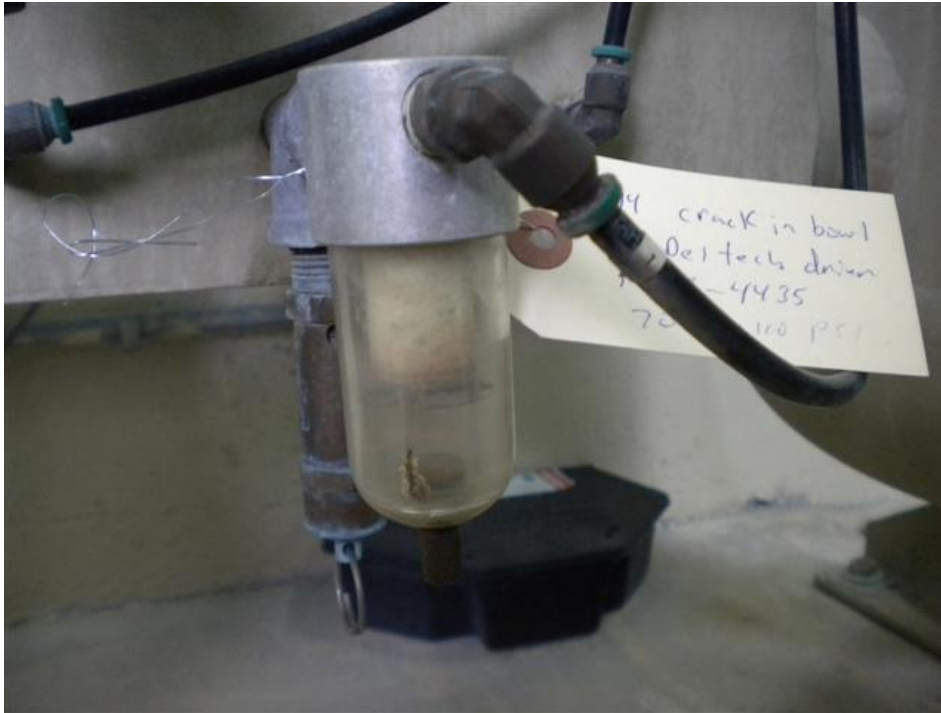
**DSCN0197.jpg**  
12/5/2009 10:26:12 AM

**CRACK IN THE BOWL**

**Location:** Main air compressor room

**Equipment:** Deltech Drier MPR-4435

**Decibel Level:** 70db

**Air Pressure:** 110psi

**Problem Description:** Crack in the bowl

**Recommended Repairs:** Replace the bowl

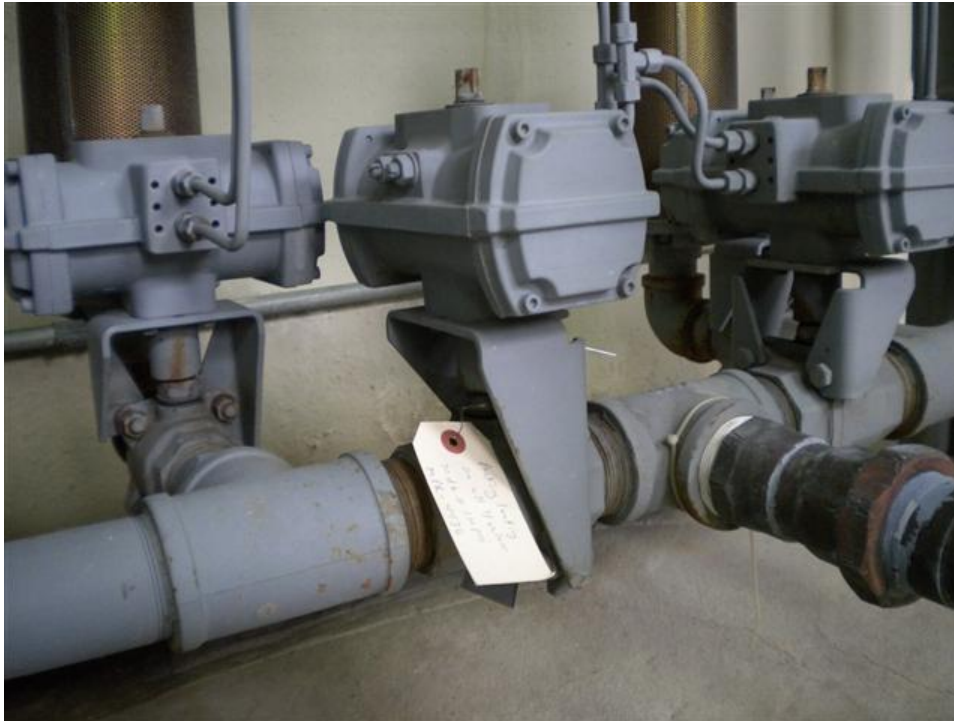
**DSCN0198.jpg**  
12/5/2009 10:30:02 AM

**LEAKING VALVES**

**Location: Main air compressor room**

**Equipment: Drier MPR-4436**

**Decibel Level: 70db**

**Air Pressure: 110psi**

**Problem Description: Air leaking from around packing nut**

**Recommended Repairs: Repair as needed**
