Waterworks saves energy

Low-friction anti-corrosion coatings restore pump efficiency

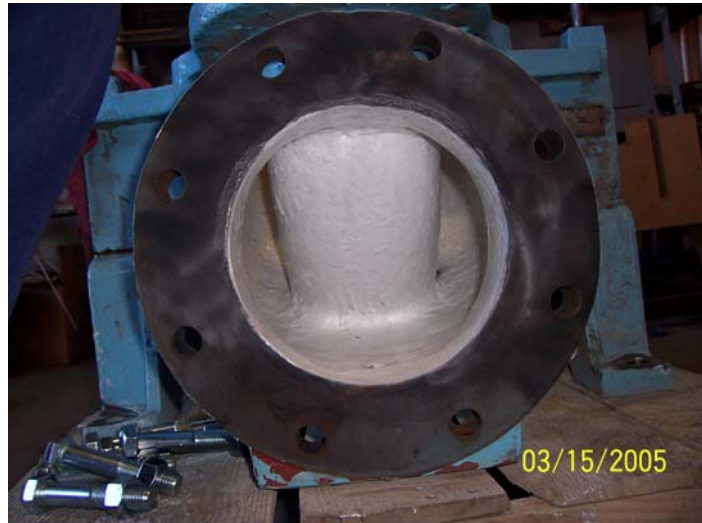
The Moseley Road pump lined with Devcon coatings showed significant efficiency gains (see figure). Its efficiency increased by approximately 18% (from about 64% to 82%) as a result of mechanical refurbishment and the cleaning and coating efforts. Based on prior experience, MCWA estimates that at least half of this total increase in pump efficiency was attributable to the cleaning and coating efforts, while the other half came from mechanical refurbishment.

The flow, head and efficiency of the Devcon-coated pump were all restored to the manufacturer's new-pump specifications. In other words, after cleaning and coating, the pump was as good hydraulically as when it was new. When the MCWA tested the pump's efficiency approximately six months after commissioning, it showed no measurable decline.

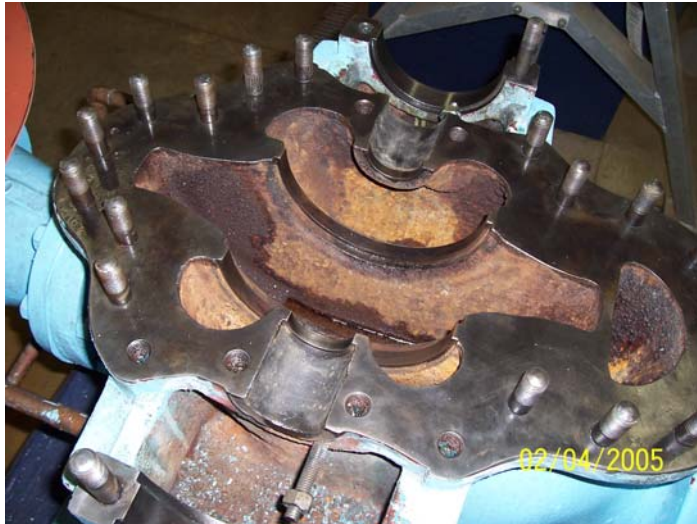
baseline wasn't established for the Moseley Road pump and two others, one of the two pumps for which this baseline was established (Woodcliff Station) showed an overall 25% efficiency increase (11% from rebuilding and 14% from sandblasting and coating).
