Keeping Whistler/Blackcomb up and running

Application Note

Testing Functions Case Study

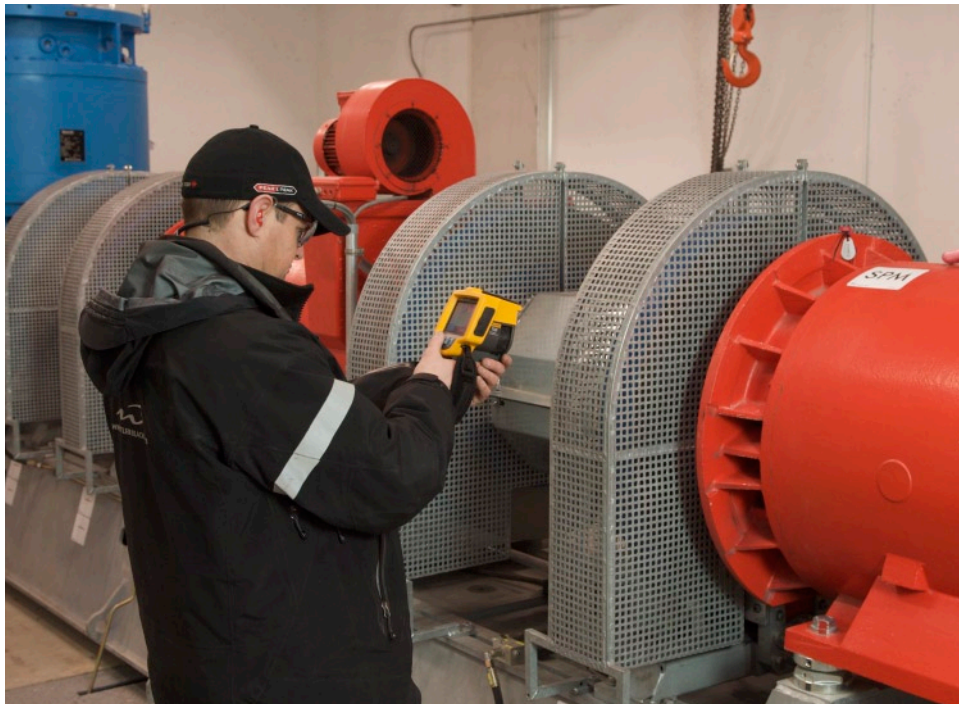
Rob Withey uses a Fluke thermal imager to check temperature on bearings and gearbox housings on the 335 kW (450 hp) motors in the Peak 2 Peak main drive room.

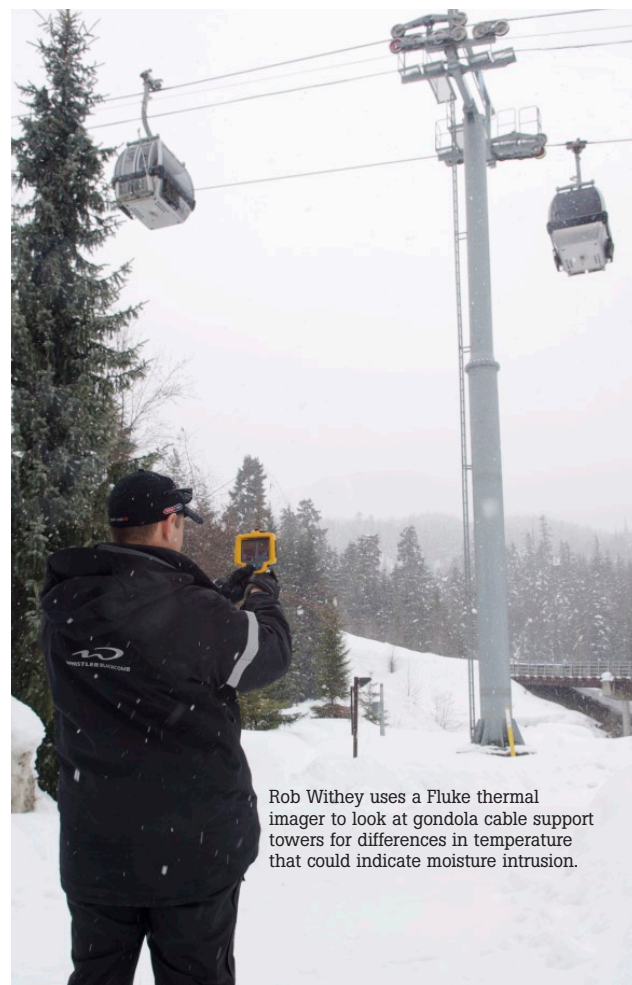
Rob Withey uses a Fluke thermal imager to look at gondola cable support towers for differences in temperature that could indicate moisture intrusion.

Towers are important parts of the ski lifts, and it's vital to make sure they're kept in good condition; here again the thermal imager proves its worth. Some towers are partly filled with

concrete, and if water were to find its way inside and then freeze it could cause damage. A concrete-filled tower shows a different thermal signature compared to an empty one, so one routine maintenance check is to take a thermal image of each tower. As long as a tower has all the same thermal "color" it means that it's okay. This kind of measurement would be difficult and quite time-consuming by any other method; with the thermal imager it's a snap.

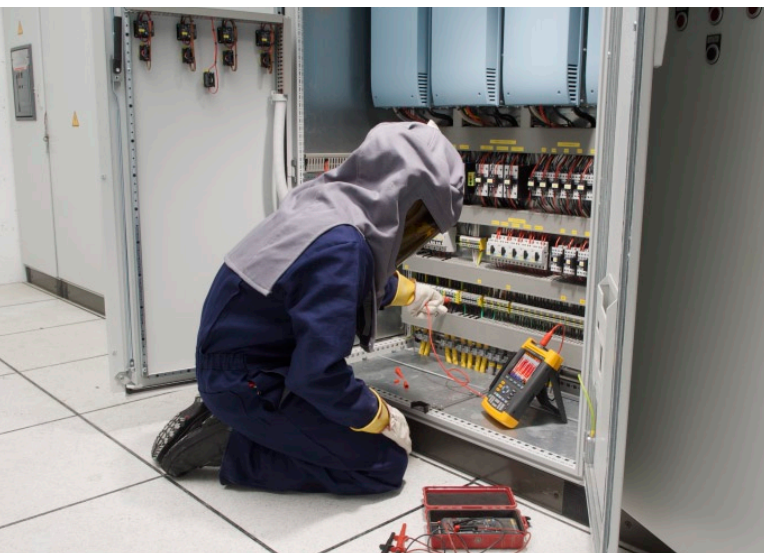
Rob Withey uses a Fluke ScopeMeter to check the output voltage that drives Peak 2 Peak conveyor motors.

They use their scope to examine the output waveforms of the ac and dc drives on an annual basis adds Withey, which provides information on the drives’ output devices, “thyristors and transistors and IGBTs, whatever the particular drive happens to have.” The ScopeMeter also helps in troubleshooting, he says, “trying to find spurious signals

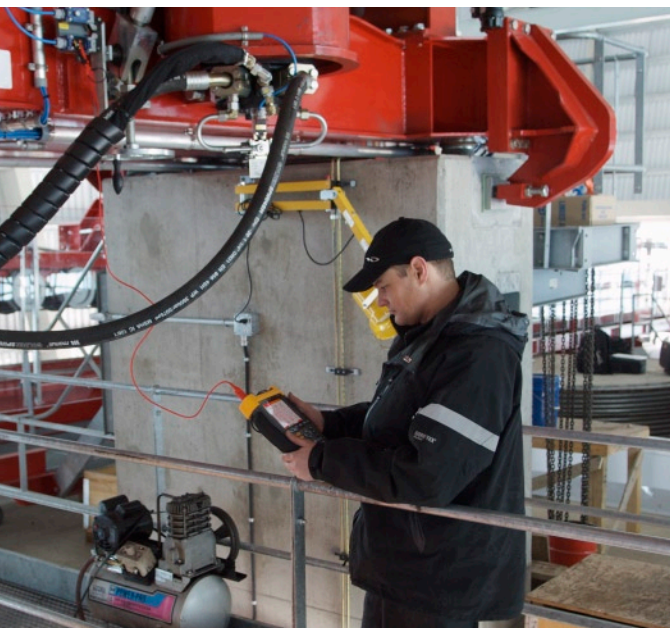
The Whistler/Blackcomb Peak 2 Peak gondola has many safety and redundant electrical systems. Rob Withey uses a Fluke ScopeMeter to look for voltage drop at a switch.
